10. ELM STREET – EDRINGTON AVENUE TO US HIGHWAY 61

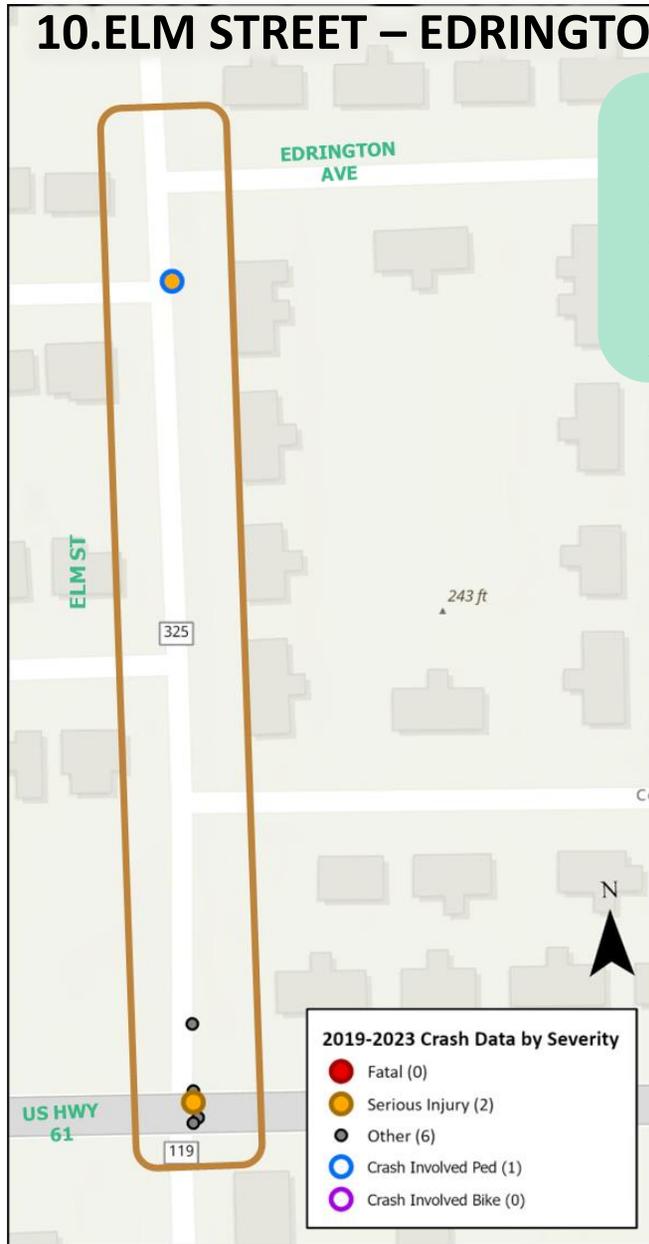
This 0.14-mile segment of Elm Street includes a High Injury Network (HIN) road segment that ranks among the top five in the East Region. Over 80 percent of reported crashes occurred at the intersection with US Highway 61, where the pavement markings are very worn and numerous driveways are located. One pedestrian crash was reported along this segment, which lacks adequate crosswalks or sidewalks. The existing sidewalks are narrow, overgrown with grass, and have cracked and uneven surfaces throughout the corridor. Public comments noted there is heavy pedestrian and bike traffic along Elm Street.

The countermeasures identified for Elm Street between Edrington Avenue and US Highway 61 are recommended to address intersection crashes and crashes involving pedestrians.

Countermeasure
Vulnerable Road User Countermeasures
Crosswalk Visibility Enhancements Sidewalks
Vehicular Countermeasures
Corridor Access Management Flashing Yellow Arrow Left Turn Signal General Pavement Markings Retroreflective Backplates Road Diet Wider Edge Lines
